Postoperative Management: Type I and III Endoleaks

Alex Powell, MD, James F. Benenati, MD, Gary J. Becker, MD, Barry T. Katzen, MD, Gerald Zemel, MD, and Srinivas Tummala, MD

The purpose of this article is to help the reader understand the importance of imaging findings and treatment strategies for type I and III endoleaks. Although the appearance of these leaks on computed tomography can be somewhat unremarkable and similar in appearance to type II endoleaks, it is critically important for the treating physician to make the correct diagnosis, as these endoleak types signify an incompletely treated aneurysm. Once the diagnosis of a type I or III endoleak is made, the next step in treatment is to identify the cause of the endoleak. Incomplete initial graft expansion, further arterial dilation, endograft migration, component separation, and tears within the graft fabric are all possible causes of type I and III endoleaks. A combination of computed tomography, plain film radiography, and diagnostic angiography may be necessary to make the diagnosis and identify the underlying cause of the complication. Once all of these factors have been determined, a decision has to be made of whet

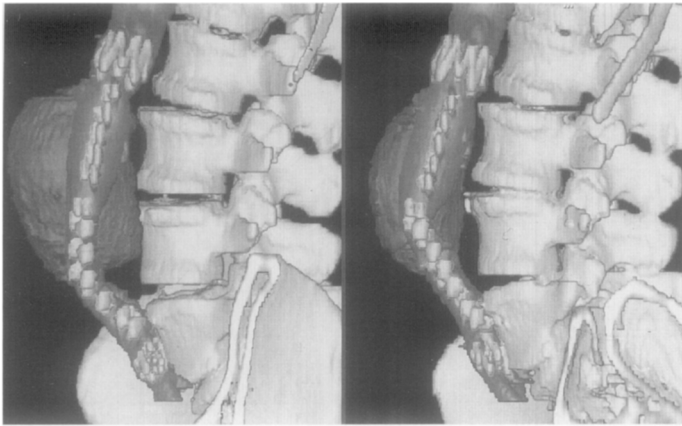
Fig 1. The effect of aneurysm remodeling on the stent-graft. Notice that with the reduction in aneurysm size there is greater anterior angulation of the stent-graft. Additionally, the point of angulation has moved superiorly. These factors can lead to graft migration and possible subsequent type I endoleak development.

Once a type I endoleak is suspected, it is first necessary to examine the implantation images to see if the leak was present at the time of implantation and went unrecognized. After this, computed tomography (CT) scans and plain film images should be obtained to determine if the graft has migrated or if there has been further dilation at one or more of the attachment sites. The value of standard abdominal radiographs cannot be stressed enough. Although a keen eye can detect a subtle inferior migration of the endograft or its individual components on CT scans, it is frequently difficult to appreciate the migration and the resultant angulation on CT images alone. These findings are readily apparent on the more global views that standard radiographs provide.

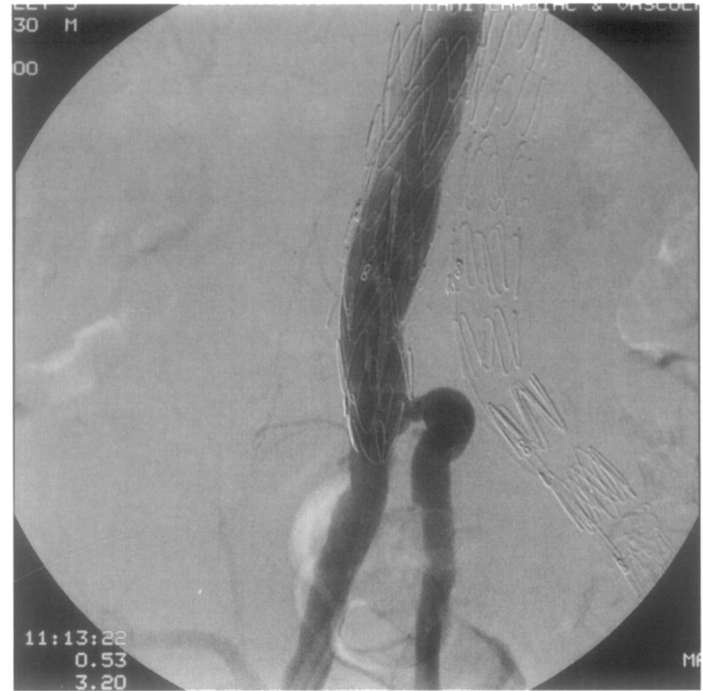
Fig 3. Treatment of type IB endoleak. Images from the same patient as shown in Fig 2. after the deployment of an additional extension into the right common iliac artery. The leak is now sealed. It should be noted that the particular design of this extension has uncovered metal at the inferior aspect, so that while metal struts were placed across the origin of the hypogastric artery, graft material was kept above the origin of the internal iliac artery.

additional anchoring area, an additional component may be added to achieve a complete seal. Figure 3 shows such a case. An additional component has been added to the distal right iliac attachment site, with successful treatment of the leak. An additional case is shown in Fig 4. Here, a tube graft has been placed inside the existing graft for treatment of a type IA endoleak. In those cases in which an additional anchoring area is not available or the graft has migrated significantly, surgical conversion may be warranted.

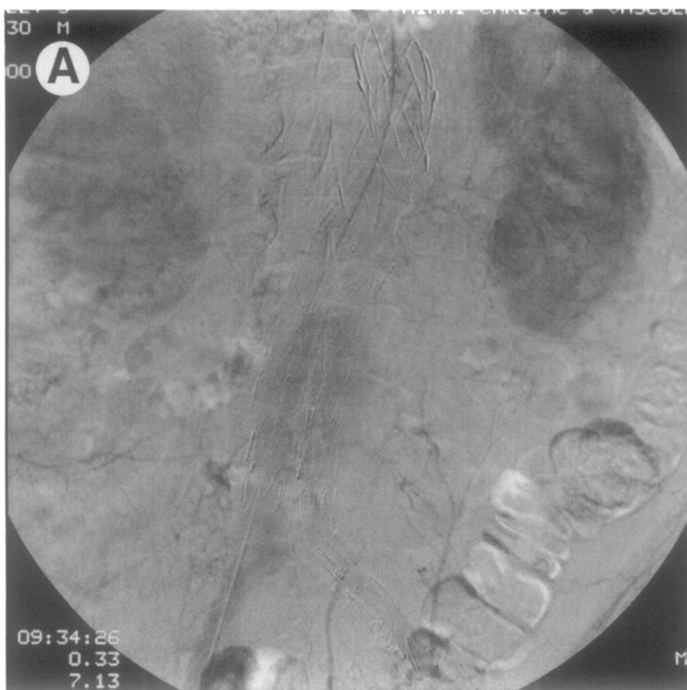
Fig 2. The value of selective angiography. Images from an aortic injection (A) only show a faint endoleak overlying the inferior aspect of the graft. However, it is not possible to discern the location of the endoleak. A selective retrograde injection (B) with the catheter in the right external iliac artery shows a large type IB endoleak arising from the distal right attachment site.

Finally, it may be necessary to perform diagnostic angiography to determine the site and type of endoleak. Figure 2 shows the value of selective injections in the determination of endoleak type and location. In this case, a standard abdominal injection showed an endoleak, but the exact type and location of the leak remained uncertain. A selective retrograde injection was then made into the right limb. With this injection, it became clear that the leak was in fact a type IB leak arising from the distal right attachment site. It is important to note that care must be taken to limit the force on these retrograde injections. If the contrast is injected too forcibly, the contrast will flow into the proximal part of the graft. This will make it difficult to pinpoint the leak location, as was the problem with the original aortic injection.

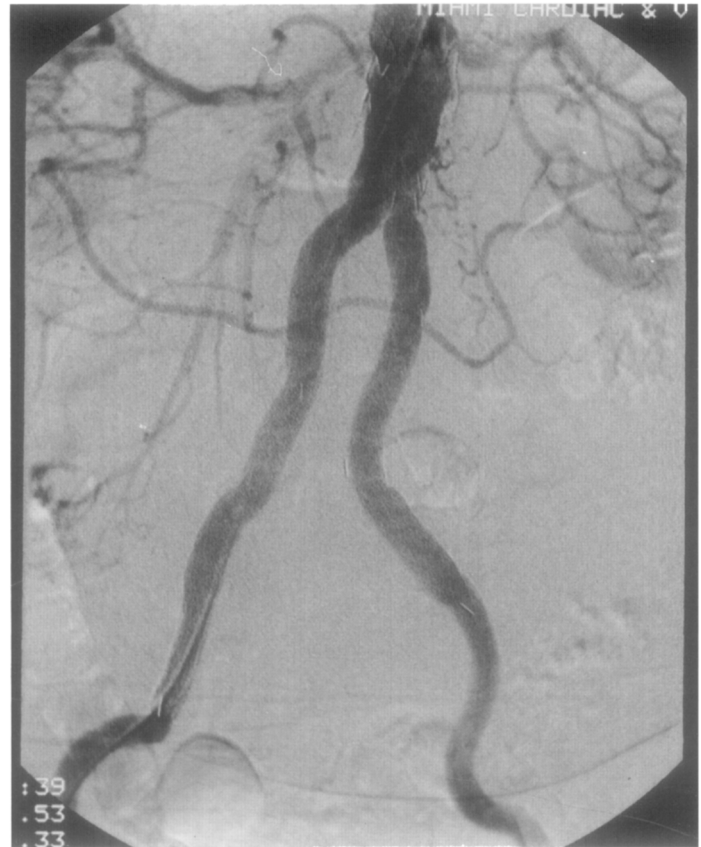
Fig 8. Type IIIB treatment. After the deployment of an additional overlapping extension into the left limb, the endoleak has been successfully treated.

leak was not present on the previous study, thus increasing the suspicion for a non-type II endoleak. A diagnostic angiogram was performed (Fig 7), which confirmed a leak arising from a hole in the fabric of the left limb. This leak was then treated by placing an additional extension that overlapped the original (Fig 8).
